Fire Effects and Fire Control in Nitrocellulose Photographic-Film Storage

National Bureau of Standards

Building Materials and Structures Report 145

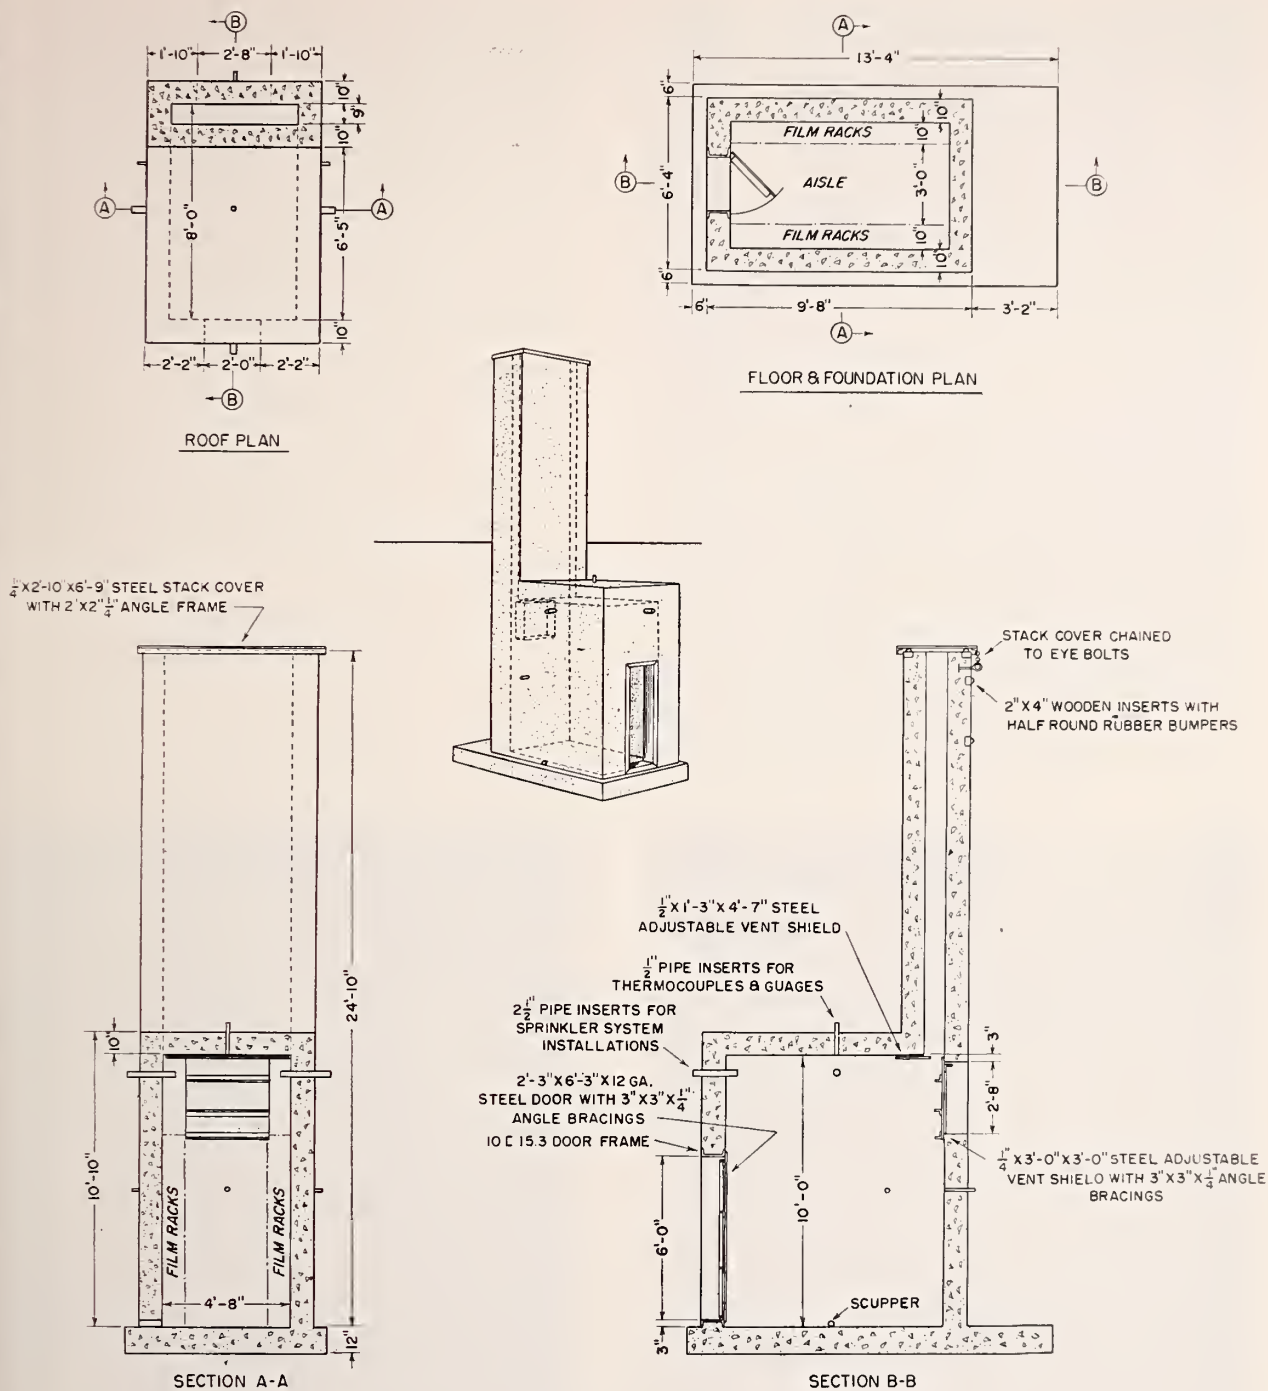
The reinforced-concrete vault, figure 1, in which two experimental programs were conducted under the direction of the Inter-Agency Committee was in the form of a cubicle with a door at one end, an opening in the opposite wall, and an opening in the ceiling at the same end as the wall opening. The ceiling opening led to a vertical vent stack, which simulated the vent of the lower vault of a two-level building. The inner dimensions of the vault were 4 ft 8 in. wide by 8 ft deep by 10 ft high. The vertical stack was an additional 14 ft 10 in. high. The walls, floor, ceiling, and stack were of 10-in.-thick reinforced concrete. The door and coverings for each vent were of steel.

Both the vertical and horizontal vents were equipped with steel plates that could be adjusted to change the area of vent opening. An experimental cover of steel, weighing 256 lb, was laid over the 504-in.² opening at the top of the vertical stack. It was held in place only by its weight. The vault door was hung to open inward and bear on the jamb on both sides, top, and bottom when closed. The vault was provided with pipes through the walls to permit the installation or connection of temperature- and pressure-measuring equipment, sprinkler systems, and fire and smoke detectors.

FIGURE 1. Construction details of 373-ft³ reinforced-concrete experimental film vault near Beltsville, Md.

The vault volume of 373 ft³ was about one-half the maximum allowed in generally accepted standards. Although the vault was not of maximum size, it was believed that the experimental results obtained therewith would be of the order of magnitude that might be obtained from experiments in a maximum-size vault. The vault was designed by members of the committee and built on the

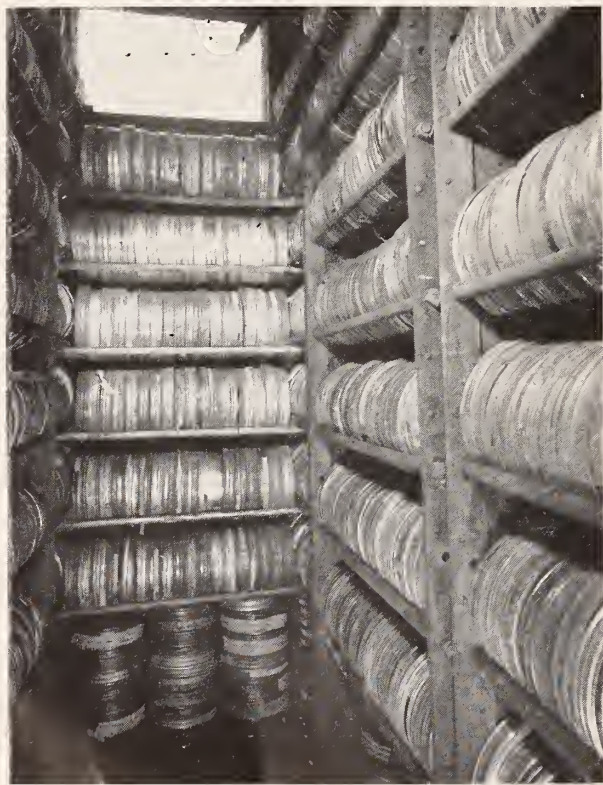
FIGURE 2. Fully loaded vertical-storage skeleton film racks in vault.

The horizontal vent opening is at the top.

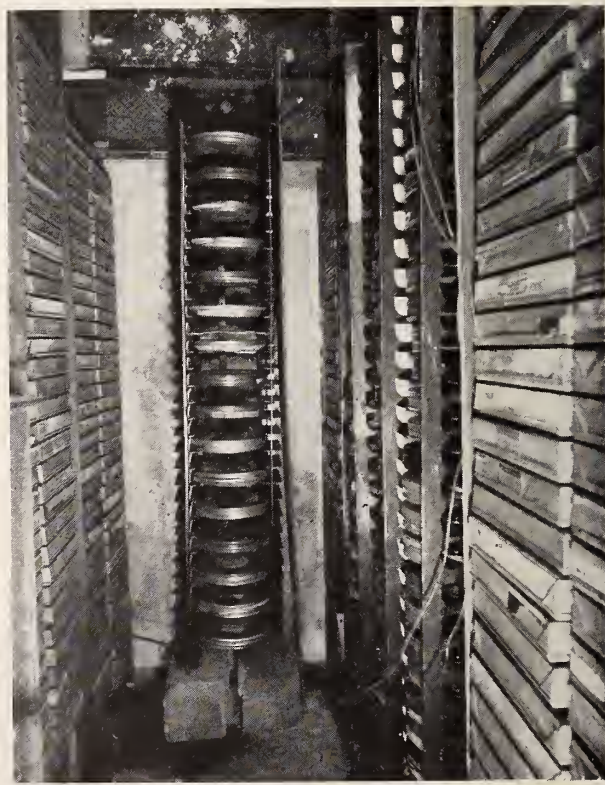
FIGURE 3. Loaded horizontal-storage skeleton film racks in vault, experiment 1.

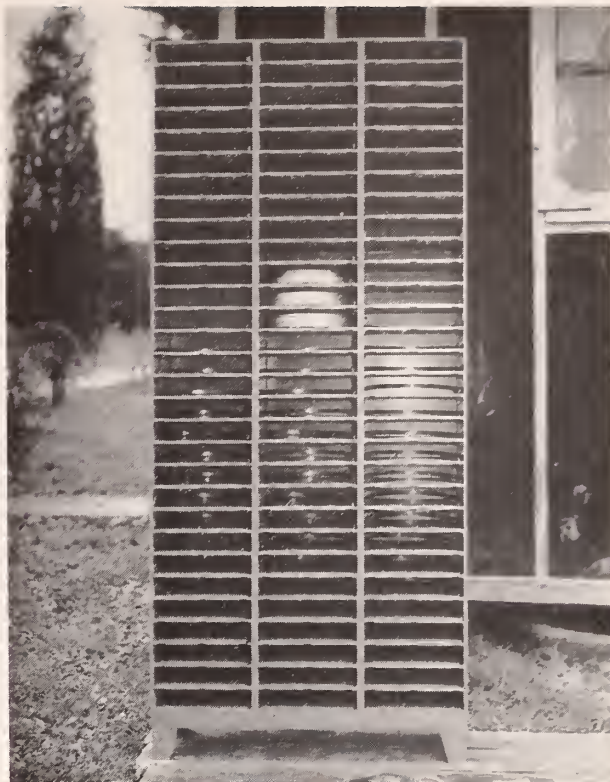
Each open-front compartmented rack consisted of three vertical rows of compartments, 30 in a row, and stood 6 in. off the floor on sheet-metal legs. The over-all dimensions were 2 ft 11 $\frac{5}{8}$ in. wide by 6 ft 11 $\frac{1}{16}$ in. high by 11 $\frac{3}{8}$ in. deep. They were constructed of light-gage sheet steel and insulated with $\frac{1}{4}$ -in. gypsum board applied to the underside of each shelf and the sides and rear of each compartment. The clear space of each compartment of the open-front rack was 11 in. wide by 11 in. deep by 2 $\frac{1}{2}$ in. high. Each compartment was equipped with a film extractor, which consisted of a flexible steel strip attached to the left front corner, from where it curved around the rear of the compartment to the right front and passed through a guide. Pulling the loose end caused the ejection of the film can. The rack is shown in figure 5.

FIGURE 5. Open-front compartmented film rack, showing film extractors.

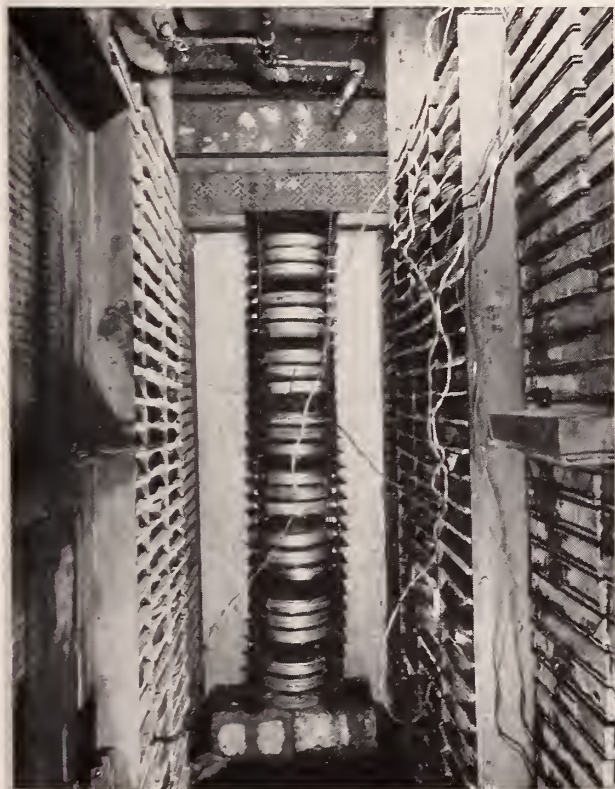
FIGURE 4. Compartmentation of horizontal-storage skeleton racks by means of insulation boards.

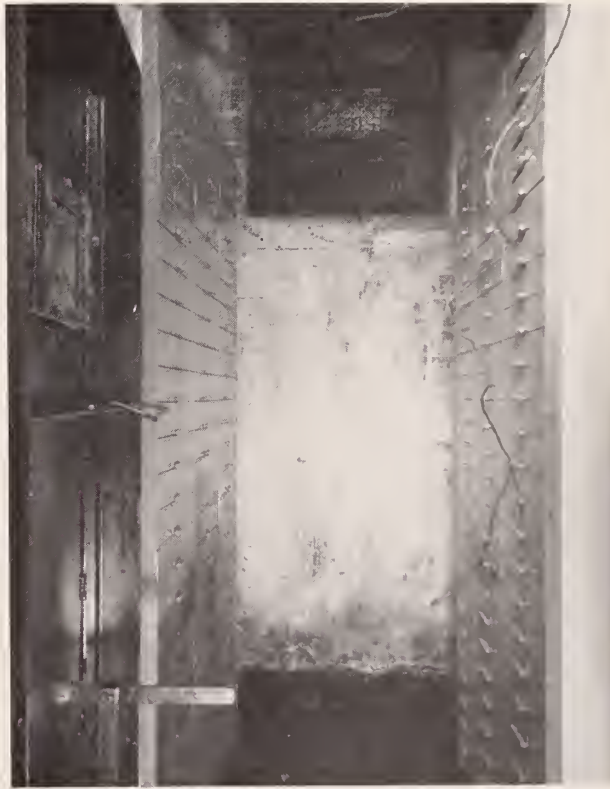
Each closed-front compartmented rack consisted of three vertical rows of compartments, 26 in a row, and stood 6 in. off the floor on sheet-metal legs. The over-all dimensions were 3 ft 1 $\frac{5}{16}$ in. wide by 6 ft 11 $\frac{1}{4}$ in. high by 1 ft $\frac{1}{4}$ in. deep. They were of the same general design as the open-front racks with the addition of an insulated door for

each compartment. The door was hung at the top from a piano-type hinge. The clear space of each compartment was $11\frac{1}{2}$ in. wide by $11\frac{1}{4}$ in. deep by $2\frac{1}{2}$ in. high. Each compartment was equipped with the same type of extractor as in the open-front rack. The rack is shown in figure 6.

FIGURE 6. Closed-front compartmented film racks in vault.

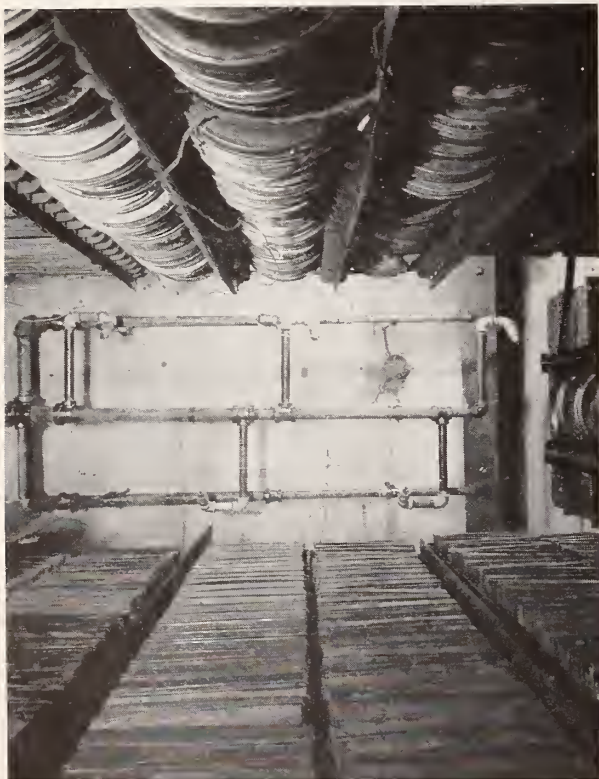
The open spray heads were used with the directed-spray system under "deluge" conditions in which discharge of all heads was actuated by a "deluge" valve located outside the vault in the supply line. Each head consisted of a hollow

FIGURE 7. Pipes for overhead sprinkler systems, with open spray heads installed, experiment 3.

bullet-shaped nozzle, inside of which was a fixed piece having a central venturi tube and three curved blades. The water entering the head was separated into two streams by the inner piece; a small central stream through the $\frac{1}{8}$ -in. venturi where its speed was increased, and a larger annular stream through the fixed blades, which gave it a rotary motion. The central and annular streams reunited as they entered the $\frac{3}{16}$ -in. orifice, producing the spray emitted from the head. Each head was designed to discharge 10 gpm at a pressure of 15 lb/in.² or 15 gpm at 32 lb/in.² pressure.

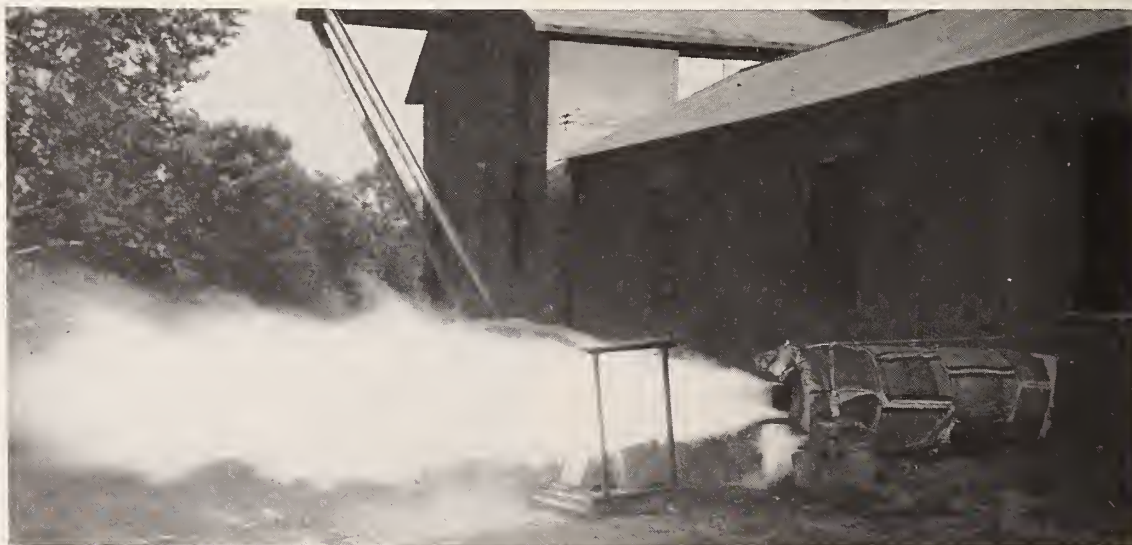
FIGURE 8. Discharge of gas and flames from 22-ft³ steel chamber during experiment 8 at National Bureau of Standards.

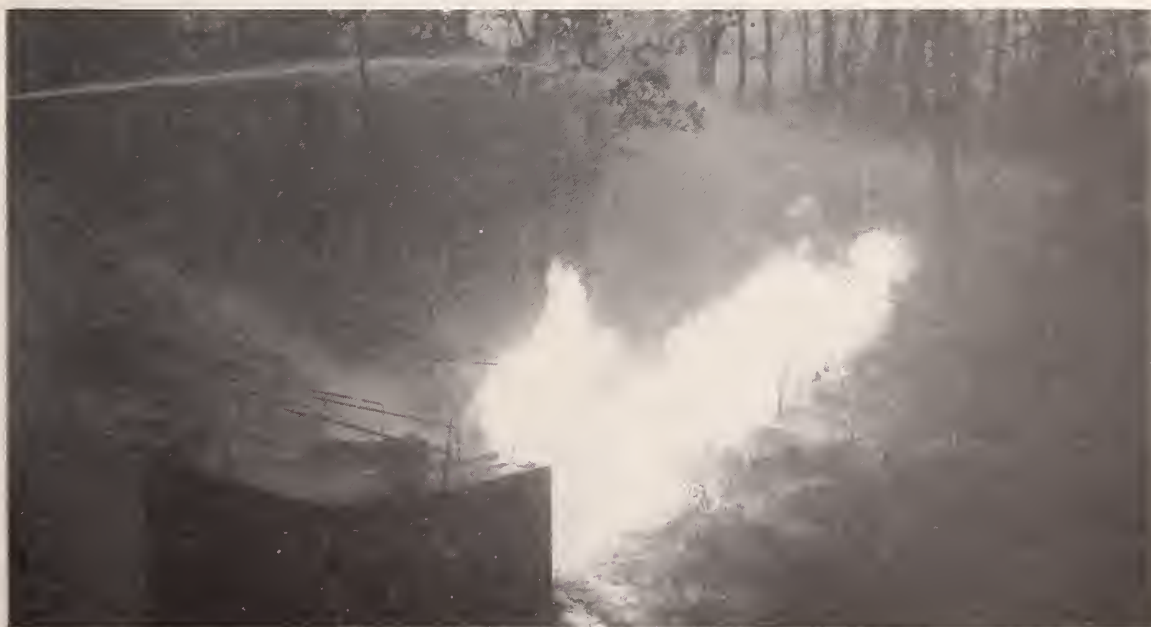
FIGURE 9. Discharge of gas and flames from 128-ft³ concrete chamber during experiment 14 at National Bureau of Standards.

Actual water flow 25.2 gpm per head, five heads operated. Apparent duration of combustion 7 min, maximum recorded pressure 0.15 lb/in.². Only about half as many cans of film burned out in rack containing the igniter can as in opposite rack. The discharge of fumes, shown in figure 9, was very dense.

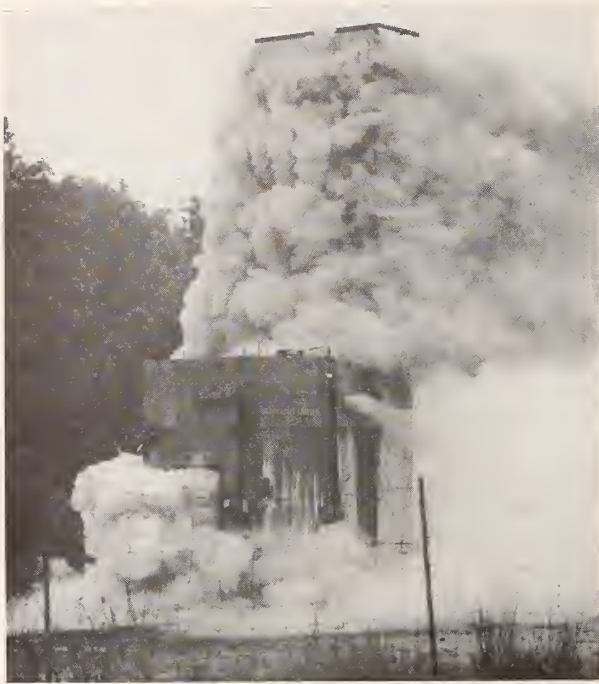
FIGURE 10. *Discharge of dense fumes from Beltsville vault during experiment 2, vent cover in place on vertical vent.*

The features observed, as well as the temperature and pressure data, varied appreciably from experiment to experiment. Following ignition of the igniter roll, fumes were produced and escaped from within the vault in clouds that ranged from light to very heavy. In 5 (9 through 13) of the 13 experiments, only 1 (No. 9) of which included sprinkler protection, the fumes became ignited outside the vault. In 1 of these 5 (No. 12) the flame lengths reached 100 ft and film was thrown over 350 ft, both distances horizontally. Flames and ejected film from the vertical vent reached estimated heights of 70 and 500 ft, respectively, in yet another (No. 11). The differences from experiment to experiment were brought about largely by the use of different types of sprinklers and regulation of the water-flow rate. No sprinklers were used in 4 of the experiments (10 through 13). Table 3 contains much of the data from the individual experiments, arranged in groups according to the type of sprinkler used. The data from this program are given in groups I through IV. The recorded temperature maxima may have been less than the true maxima due to the limited number of thermocouples and their locations in the vault as well as the possibility of wetting of thermocouple junctions in sprinkler discharges. However, the tabulated temperatures give an indication of the order of magnitude that might be expected. Discharges of dense fumes and flames from the vertical and horizontal vents are shown in figures 10 through 14.

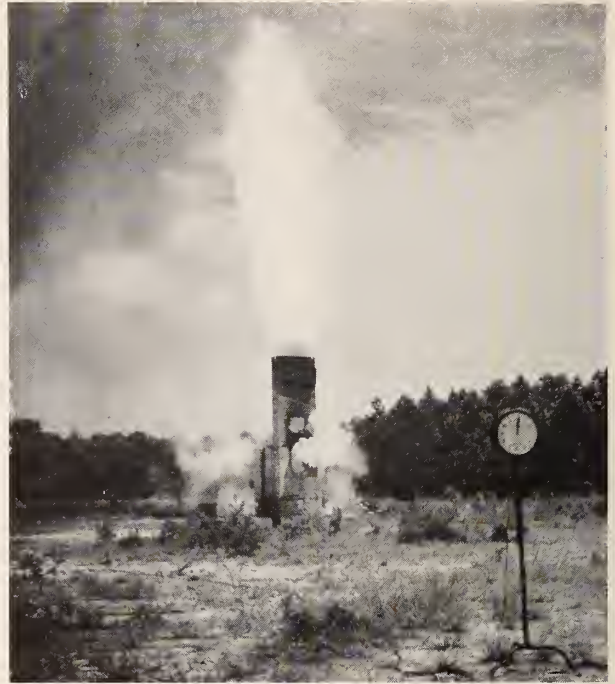
FIGURE 11. *Discharge of flames about 60 ft above vertical vent after vent cover blown off, experiment 11 in Beltsville vault.*

Actual water flow 14.8 gpm per head, until increased to 24.3 gpm per head at 16 min 30 sec, six heads operated. All but about 7 percent of the film was burned out. Nearly all of the unburned film was in the bottom racks on the side opposite the igniter can. The fire could not be controlled by the initial water flow and only after several minutes, if at all, by the maximum flow obtainable. However, the duration of combustion indicated that the sprinklers retarded the rate of combustion. The maximum recorded temperature and pressure were 1,562° F (850° C) and 0.22 lb/in.², respectively. Figure 11 shows the cloud of fumes just as their ignition started at the vent.

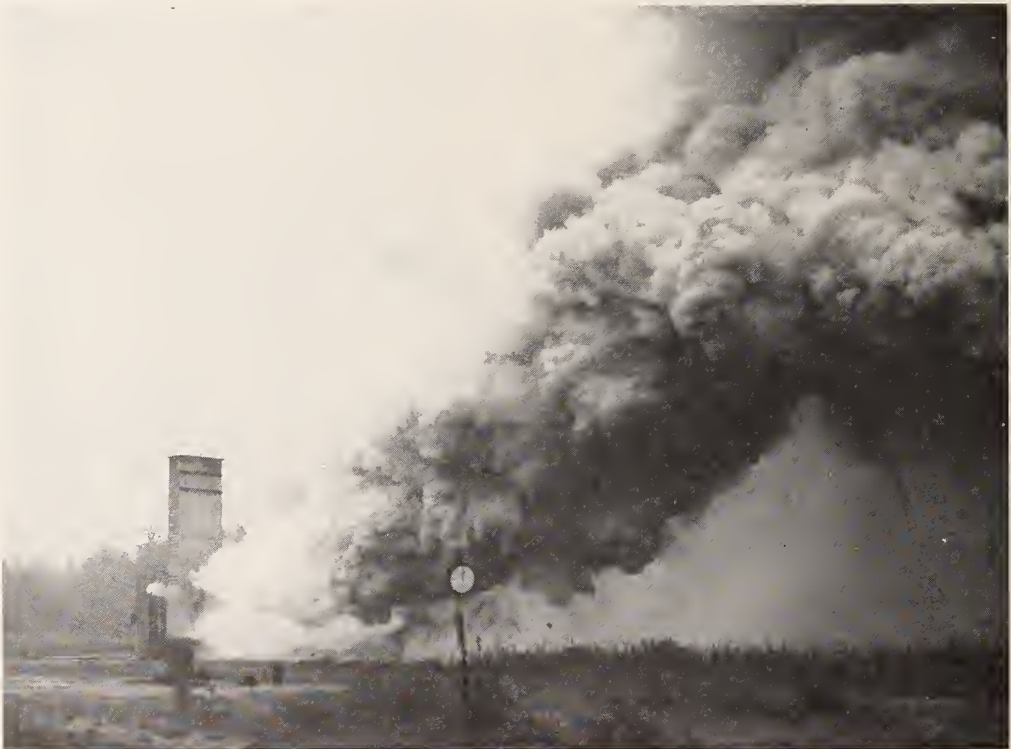
FIGURE 12. *Discharge of very dense fumes from horizontal vent just as ignition of fumes initiated at vent, experiment 9.*

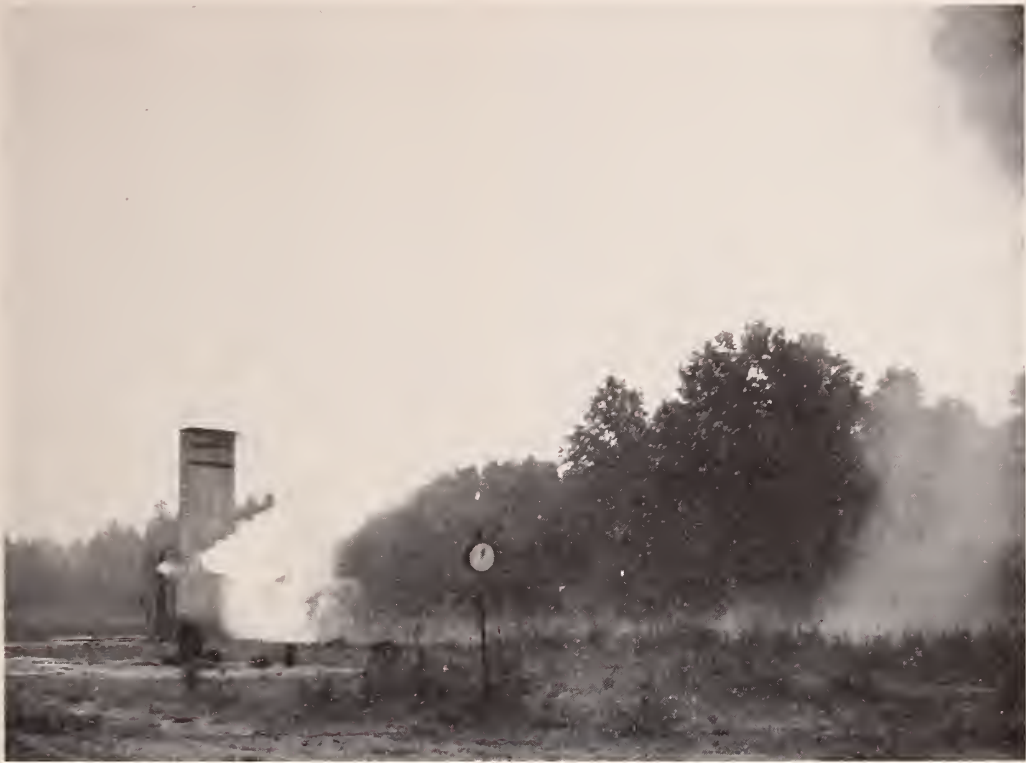
FIGURE 13. *Appearance during experiment 9 about 10 sec after that in figure 11, showing that dense fumes were almost completely burned.*

All the film in the vault was burned. Film was blown through the vent to distances up to 350 ft from the vault and flame length was at least 100 ft. The maximum recorded pressure was 3.0 lb/in.² and the maximum recorded temperature exceeded 2,192° F (1,200° C), the full scale of the potentiometer, for a period of 40 sec. Figure 13 shows the discharge of flames and film during this experiment.

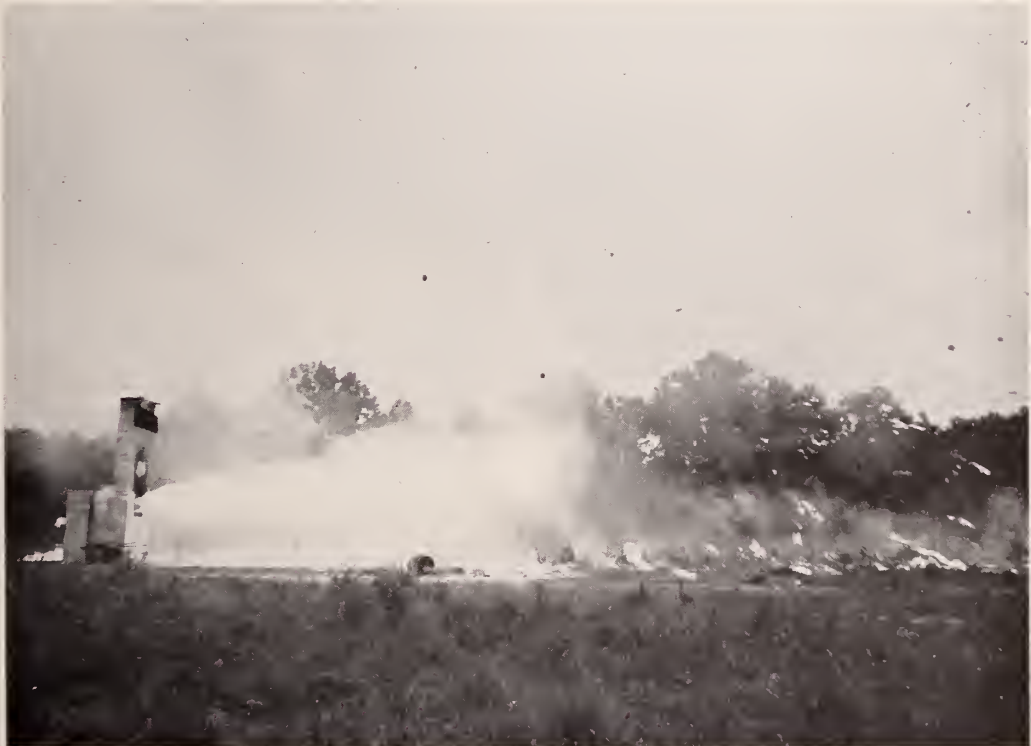
FIGURE 14. *Violent discharge of flames, film cans, and film from horizontal vent during experiment 12.*

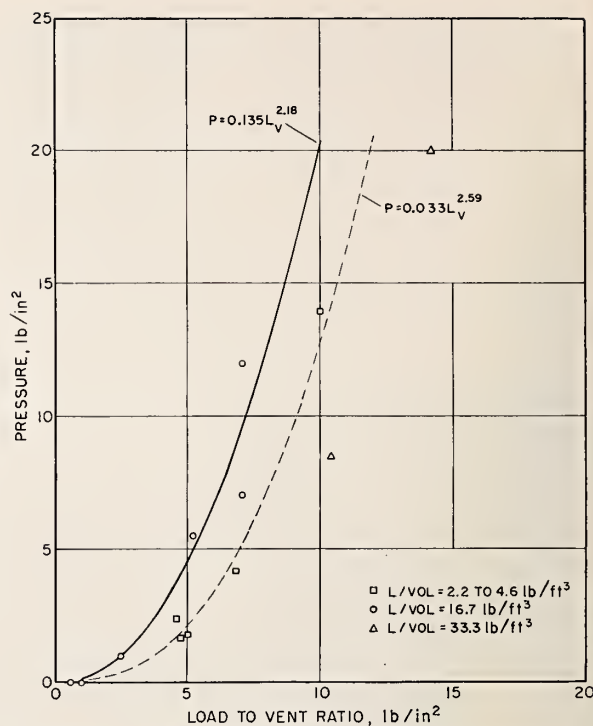
Figure 15 is a plot of the data obtained from experiments with film on bare reels or loose film. It includes data from NBS experiments and Stewart's [5] experiments except two of the latter in which extreme pressures of short duration were

FIGURE 15. Pressure as function of load-to-vent ratio for film not in containers.

attributed to temporary reduction of vent area through partial obstruction by film. The curves were plotted from formulas derived by least-squares analyses of the data. The solid curve represents the relationship

It should be borne in mind that the formulas and curves are intended to apply to only those cases in which the cellulose nitrate film is loose or on open reels, is stored without automatic sprinklers or equivalent protection, and is so placed in the vault or chamber that the vent will not be even partially obstructed at any time. The formulas do not include any extra margin of factor of safety.
